Piper Aircraft, Inc.
 2926 Piper Drive
 Vero Beach, FL, U.S.A. 32960

SERVICE NO. 1345A BULLETIN

Date: September 17, 2021

MAIN WING SPAR INSPECTION

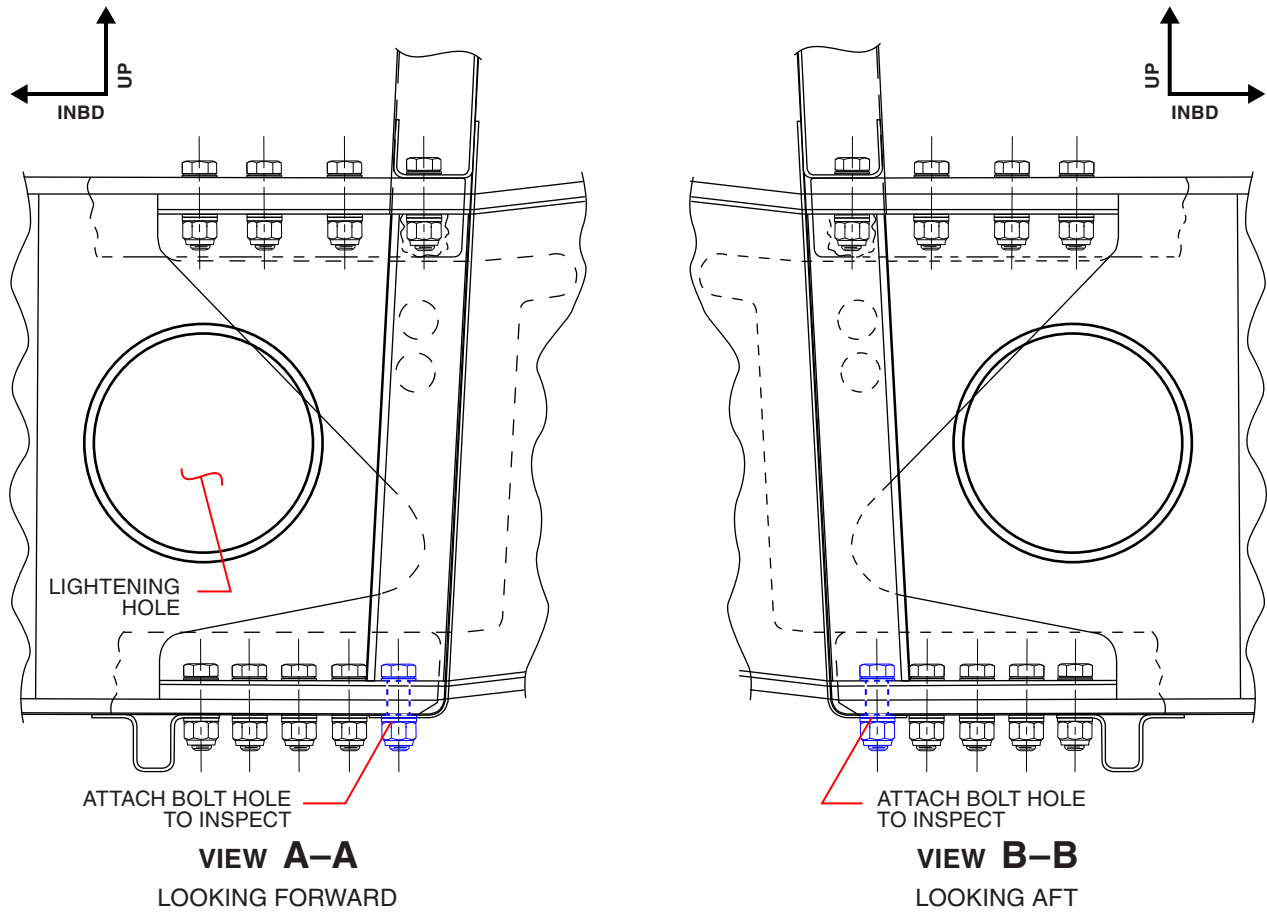
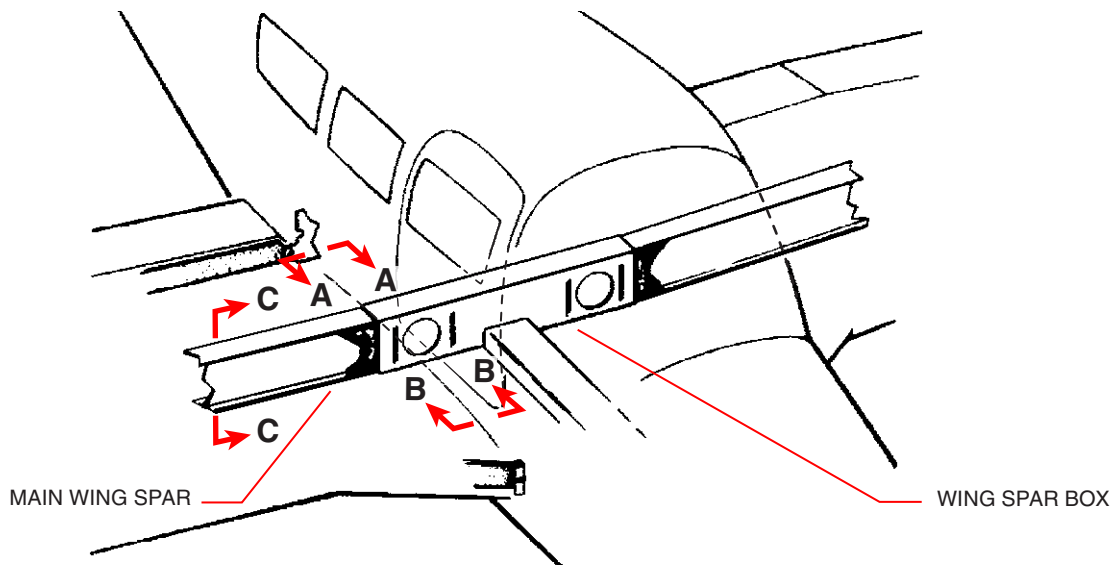
Figure 1, Sheet 1 of 2
Typical Main Wing Spar Attach Bolts and Spar Cross Section (Right Wing Shown)

3. Inspect the inner surface of each bolt hole in the lower wing spar cap. Figure 1 provides cross sections of the main wing spar, and identifies the bolt hole inspection areas.

NOTE: When radius washers are properly installed, the radius feature of the washer will be oriented to match the radius of the adjacent structure, as shown in Figure 1, Detail D.

WARNING: Do not drive bolts into or out of the main spar attaching bolt holes (see Views A-A and B-B). Be careful to avoid damaging the bolt holes while removing and replacing the bolts. Refer to "Care for Bolts and Bolt Holes" in this service bulletin.
