Piper Aircraft, Inc.
 2926 Piper Drive
 Vero Beach, FL, U.S.A. 32960

SERVICE NO. 1345A BULLETIN

Date: September 17, 2021

MAIN WING SPAR INSPECTION

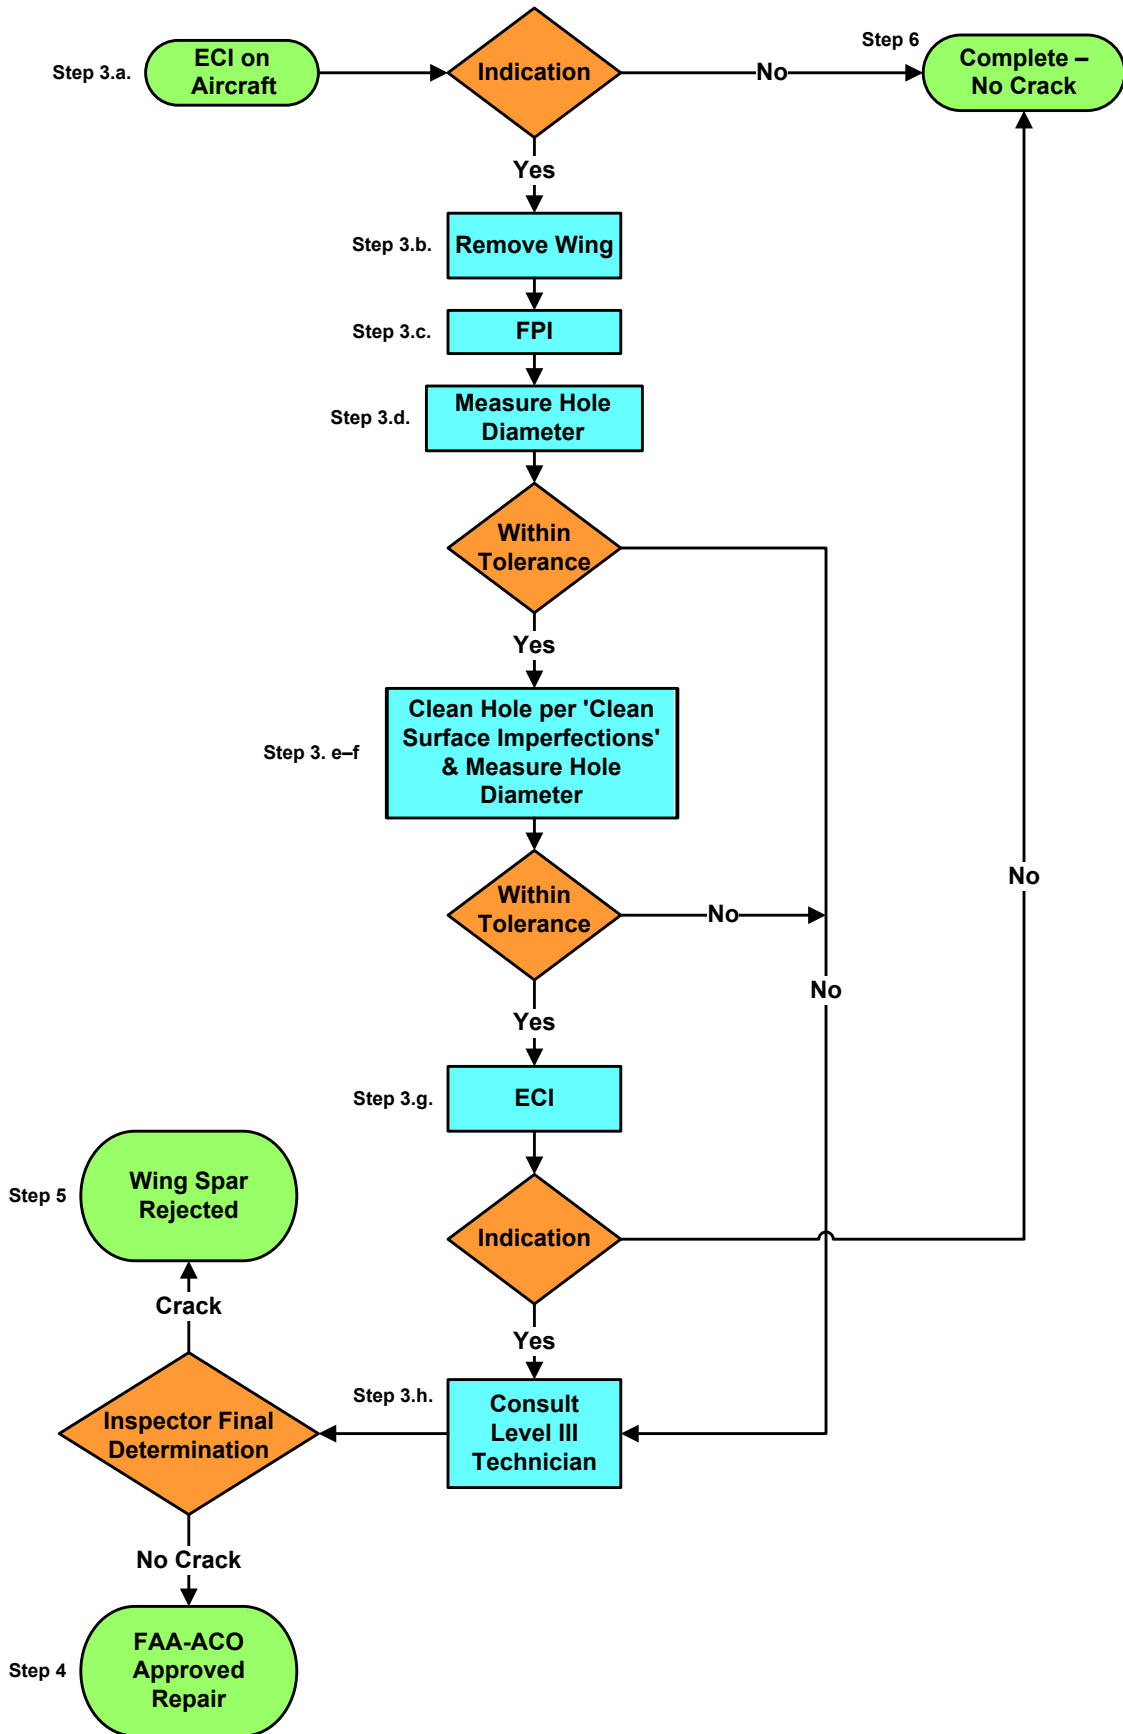
Figure 2
Inspection Process Flowchart

- The inspection steps in these instructions are visualized in Figure 2, a process flowchart.
 - It is recommended that technicians prepare and/or enter their responses on the feedback form throughout the inspection process. (For legibility, fill out the form digitally, printing it only for signature purposes.)
